# City of Ashland FCA

## PUBLIC WORKS, PARKS, AND REC

ASHLAND, OR  
JUNE 25, 2024

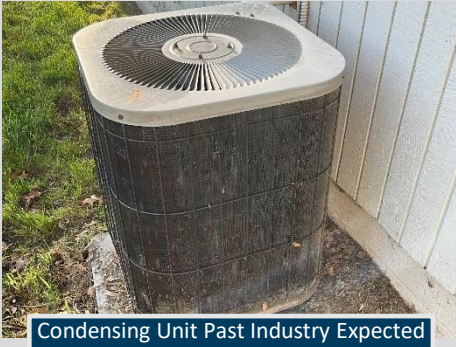
Condensing Unit Past Industry Expected Life
