# City of Ashland FCA

## PUBLIC WORKS, PARKS, AND REC

ASHLAND, OR  
JUNE 25, 2024

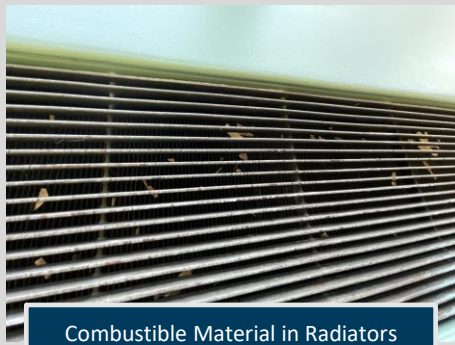
Combustible Material in Radiators

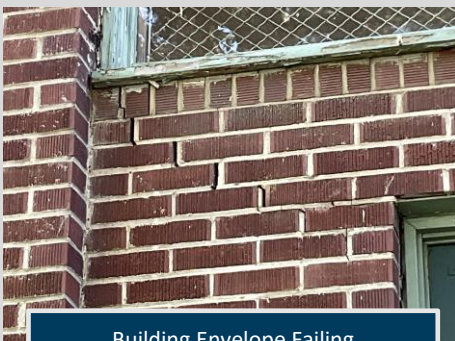
Original doors and windows dating back to the 1950s exhibit significant deterioration. Additionally, the northeast exterior wall of the gymnasium displays masonry failure, posing safety hazards and structural integrity concerns. Furthermore, the roofing system has surpassed its useful life, leading to pervasive leaks and moisture intrusion throughout the building.

Building Envelope Failing

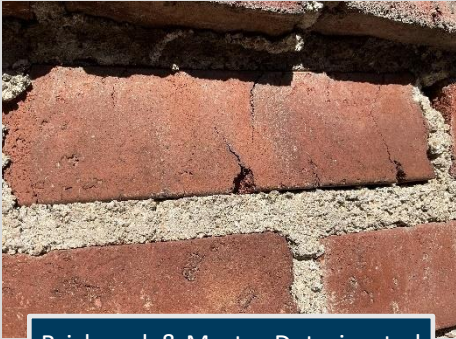
The building envelope exhibits significant structural deficiencies, including failures in the brickwork and mortar. Additionally, the roofing has exceeded its useful life, and windows installed across different decades require attention. Comprehensive repairs and replacements are essential to maintain the integrity and functionality of the building envelope.

Brickwork & Mortar Deteriorated

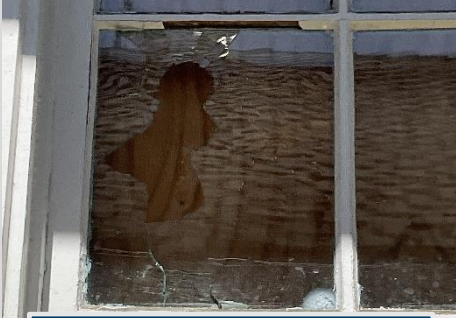
The building's envelope is predominantly original construction (1920), with subsequent installation of the roof in 1996. The windows are in a deteriorated state, with some boarded up and damaged. Repairing or replacing the windows and roof is recommended to enhance energy efficiency, aesthetics, and structural integrity.

Single Pane Windows Damaged

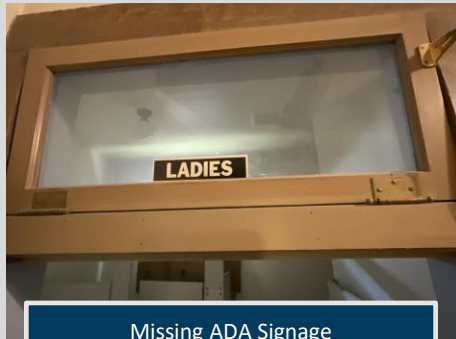
Missing ADA Signage

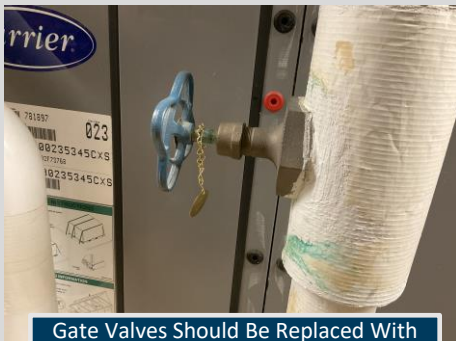
Gate Valves Should Be Replaced With Ball Valves

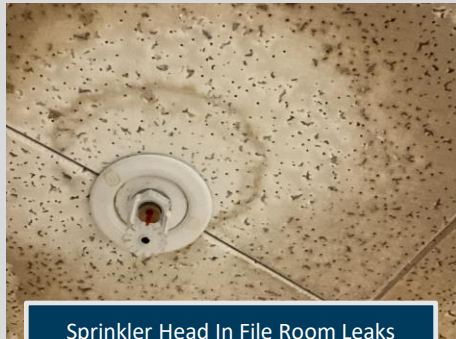
Sprinkler Head In File Room Leaks

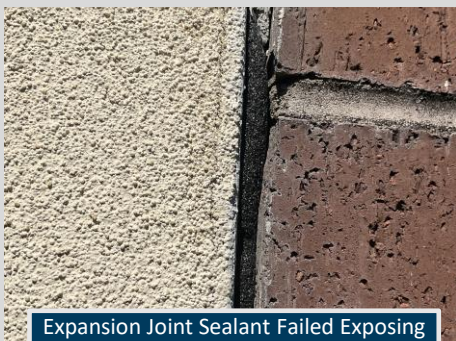
Apart from the failing joint sealant, the building envelope is adequate. Nonetheless, plans should be made to replace the TPO roofing system to maintain structural integrity and weather resistance.

Expansion Joint Sealant Failed Exposing Backer Rod

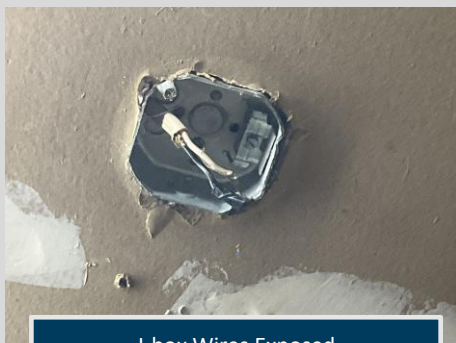
J-box Wires Exposed

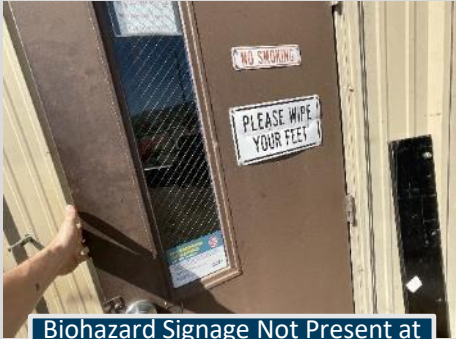
Biohazard Signage Not Present at Welding Shop

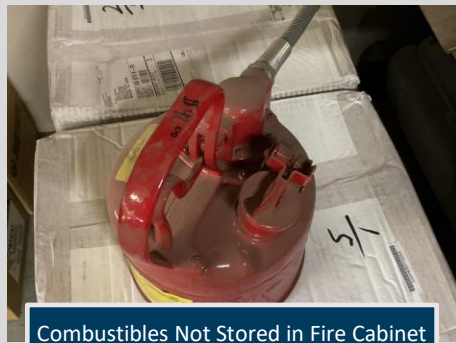
Combustibles Not Stored in Fire Cabinet

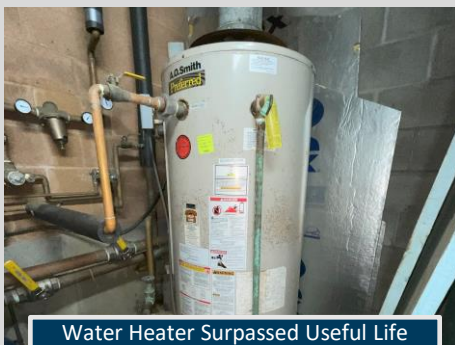
Water Heater Surpassed Useful Life Expectancy

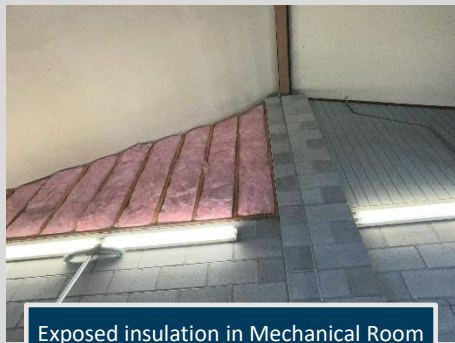
Exposed insulation in Mechanical Room

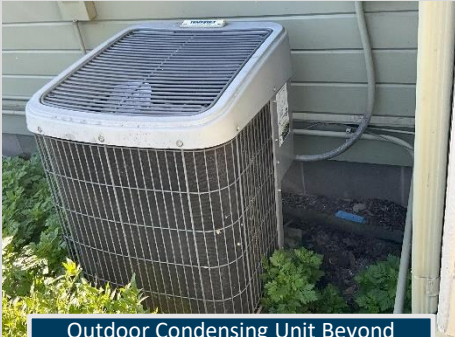
Outdoor Condensing Unit Beyond Industry Expected Life

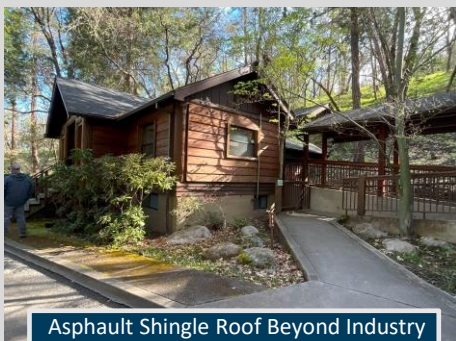
Asphalt Shingle Roof Beyond Industry  
Expected Life

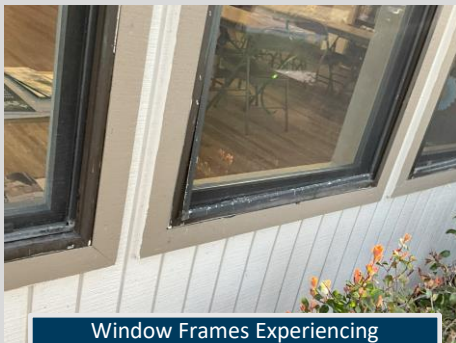
Window Frames Experiencing Weathering
