# City of Ashland FCA

## PUBLIC WORKS, PARKS, AND REC

ASHLAND, OR  
JUNE 25, 2024

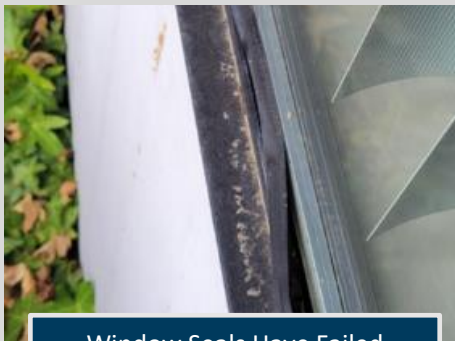
The building envelope is deemed adequate considering its age; however, the windows are significantly past their useful life and should be planned for replacement. Additionally, both the thermoplastic roofing and asphalt mansard roofing have exceeded their useful life and should be scheduled for replacement.

Window Seals Have Failed

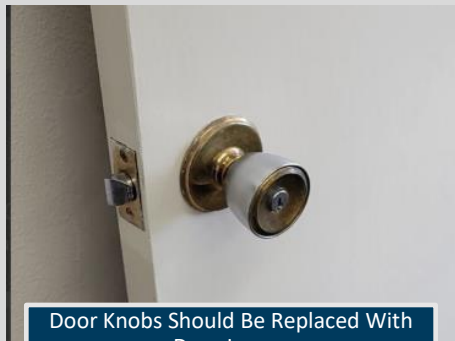
Door Knobs Should Be Replaced With Door Levers

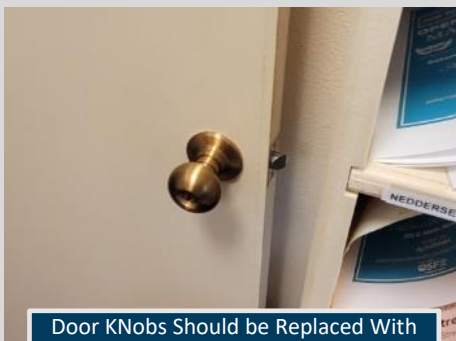
Door KNObs Should be Replaced With Door Levers

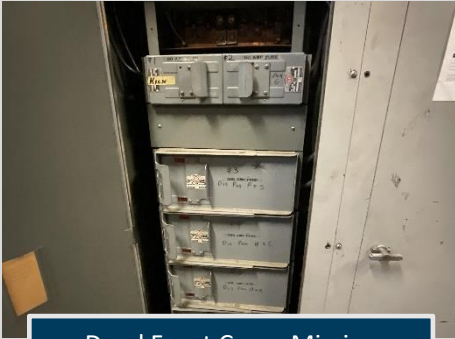
Dead Front Cover Missing

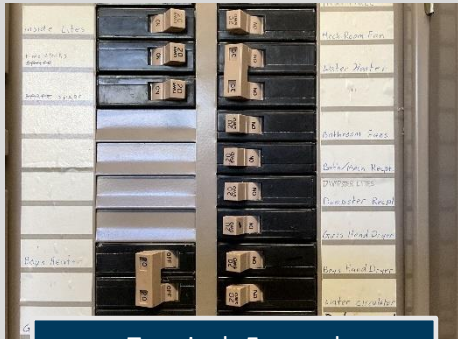
Terminals Exposed

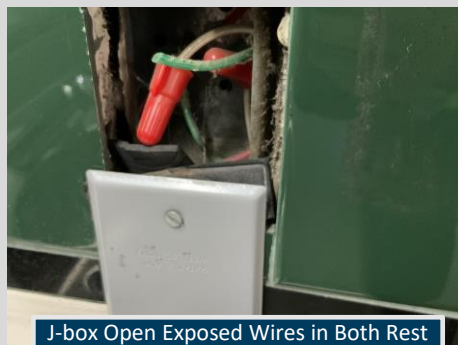
J-box Open Exposed Wires in Both Rest Rooms

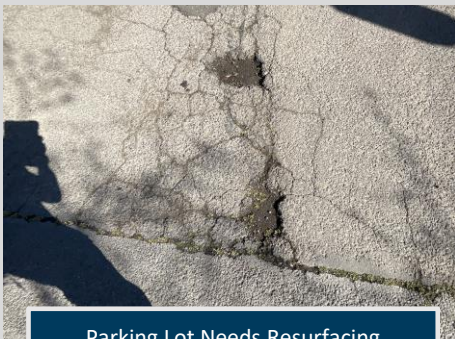
Parking Lot Needs Resurfacing

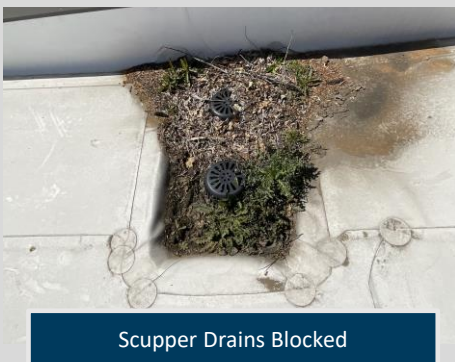
Scupper Drains Blocked

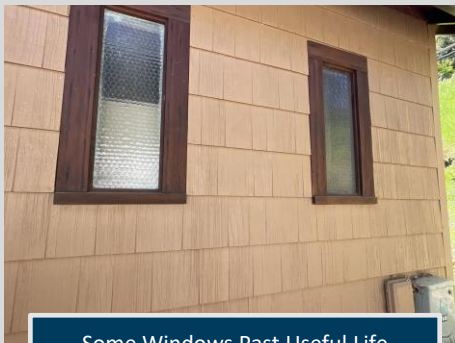
Some Windows Past Useful Life

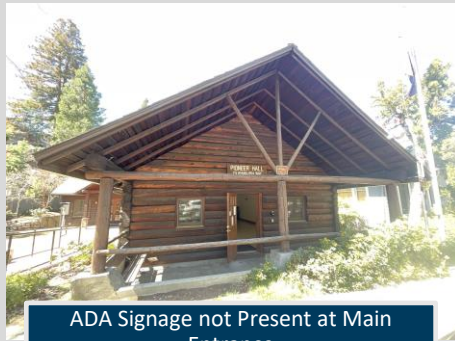
ADA Signage not Present at Main Entrance

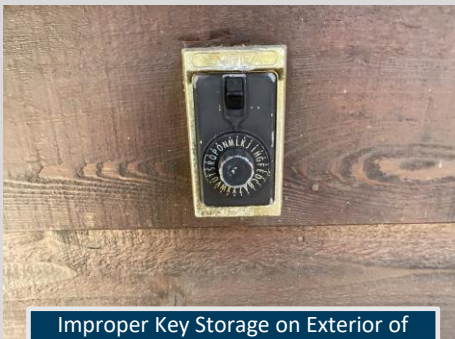
Improper Key Storage on Exterior of Building

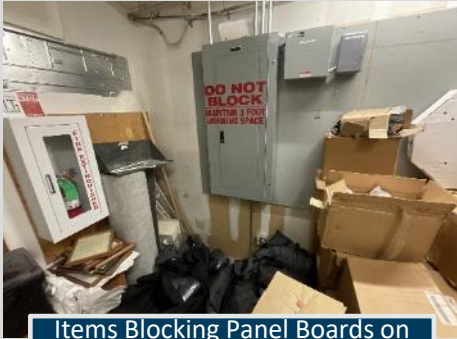
Items Blocking Panel Boards on 2nd Floor

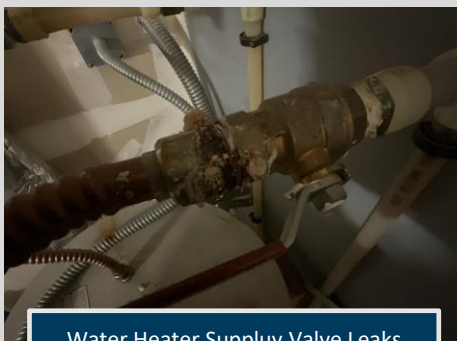
Water Heater Supply Valve Leaks

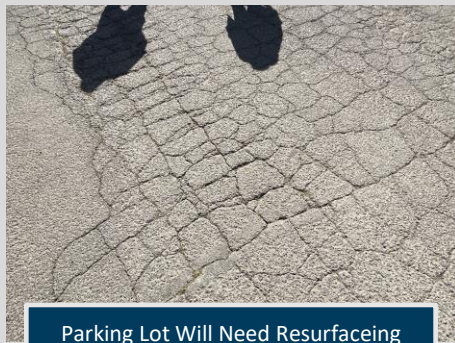
Parking Lot Will Need Resurfacing

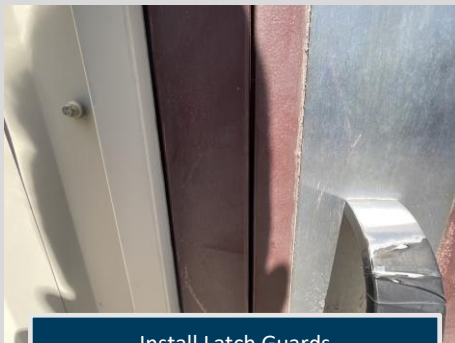
Install Latch Guards

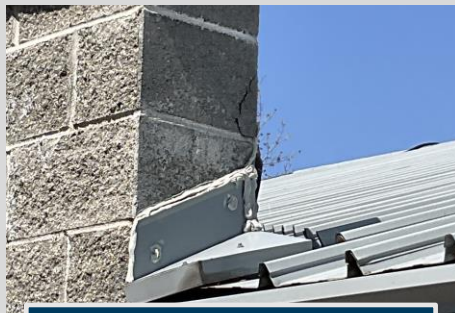
Flashing Needs Replacement

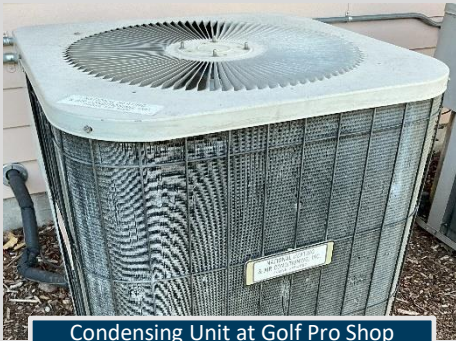
Condensing Unit at Golf Pro Shop  
Beyond Useful Life Expectancy.

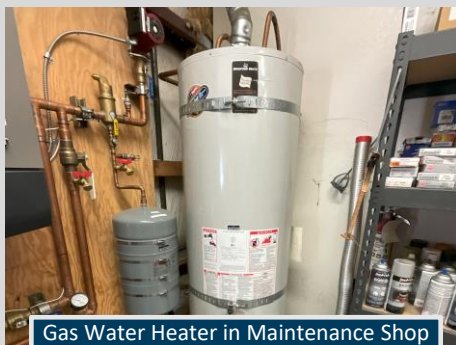
Plumbing systems were minimal throughout the buildings, although the natural gas water heater within the Maintenance Shop has exceeded its useful industry life and requires replacement.

Gas Water Heater in Maintenance Shop  
Beyond Useful Life Expectancy

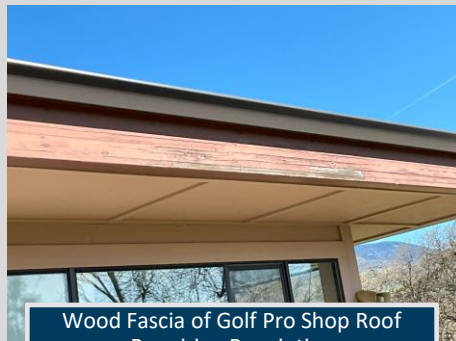
Wood Fascia of Golf Pro Shop Roof  
Requiring Repainting

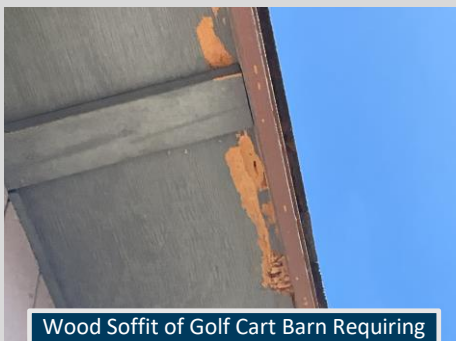
Wood Soffit of Golf Cart Barn Requiring  
Repair

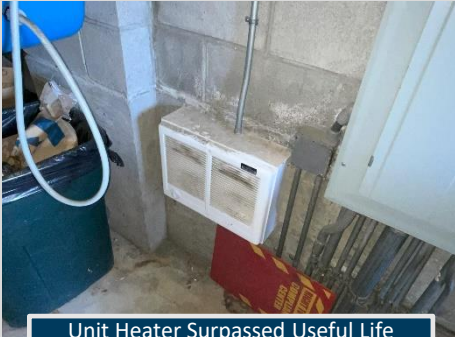
Unit Heater Surpassed Useful Life Expectancy

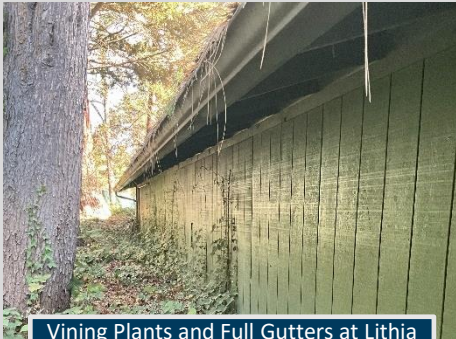
Vining Plants and Full Gutters at Lithia Park Material and Equipment Storage

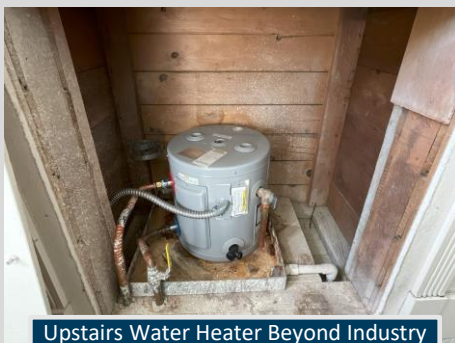
Upstairs Water Heater Beyond Industry Expected Life

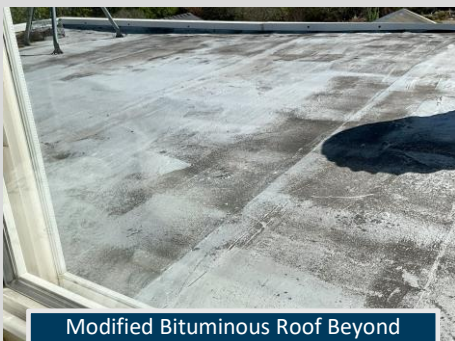
Modified Bituminous Roof Beyond Industry Expected Life.

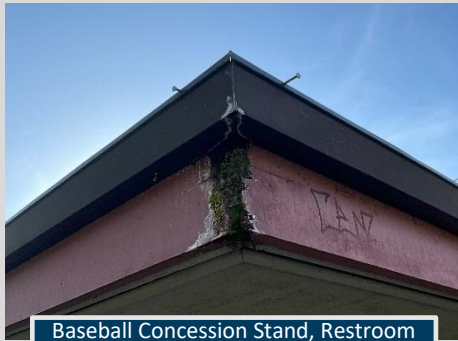
The roofs of all buildings are due for replacement due to age, and the roof fascia of all buildings except the Baseball Batting Cages and Storage is rotting in some corners, necessitating repair or replacement to protect the structural integrity of the buildings. Additionally, the windows of the Softball Material and Equipment Storage building have exceeded their industry expected life.

Baseball Concession Stand, Restroom and Clubhouse Roof Fascia Rotting

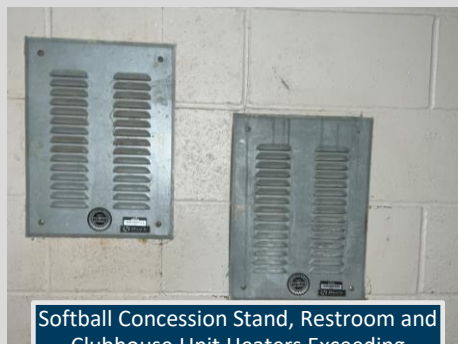
Softball Concession Stand, Restroom and Clubhouse Unit Heaters Exceeding Useful Life

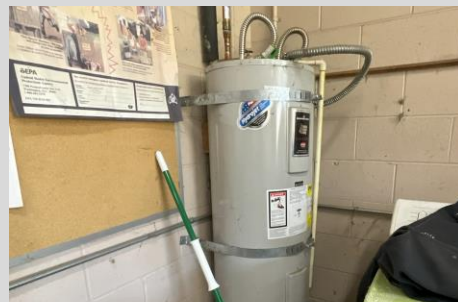
Softball Material and Equipment Storage Water Heater Exceeding Useful Life

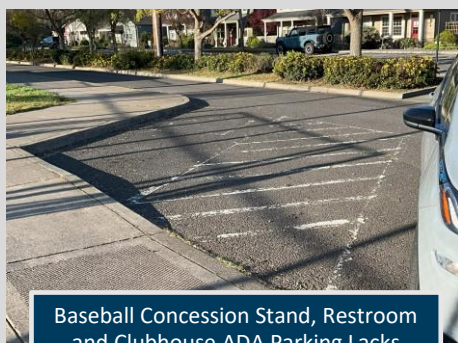
Where parking is available, the number of parking spaces for ADA requirements are considered sufficient, and all include van accessible spaces with adjoining access aisles. However, the paint in all lots is in poor condition, and all spots lack appropriate signage.

Baseball Concession Stand, Restroom and Clubhouse ADA Parking Lacks Signage

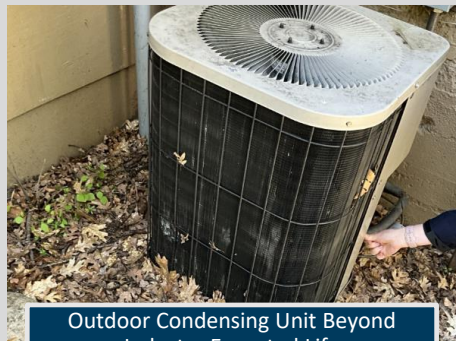
Outdoor Condensing Unit Beyond  
Industry Expected Life

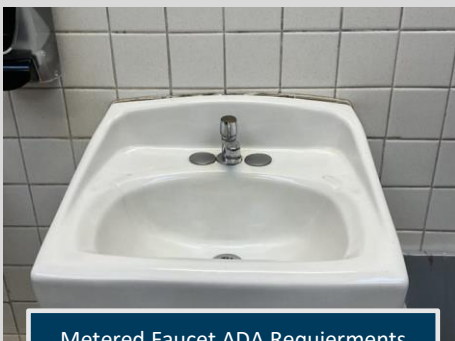
Metered Faucet ADA Requirements

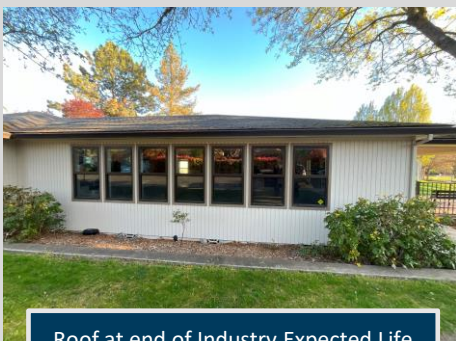
Roof at end of Industry Expected Life
